**1/2009**

**Kvartalsvis Orientering  
Opklaringsenheden**

***Quarterly Information  
Division for Investigation of Maritime Accidents***

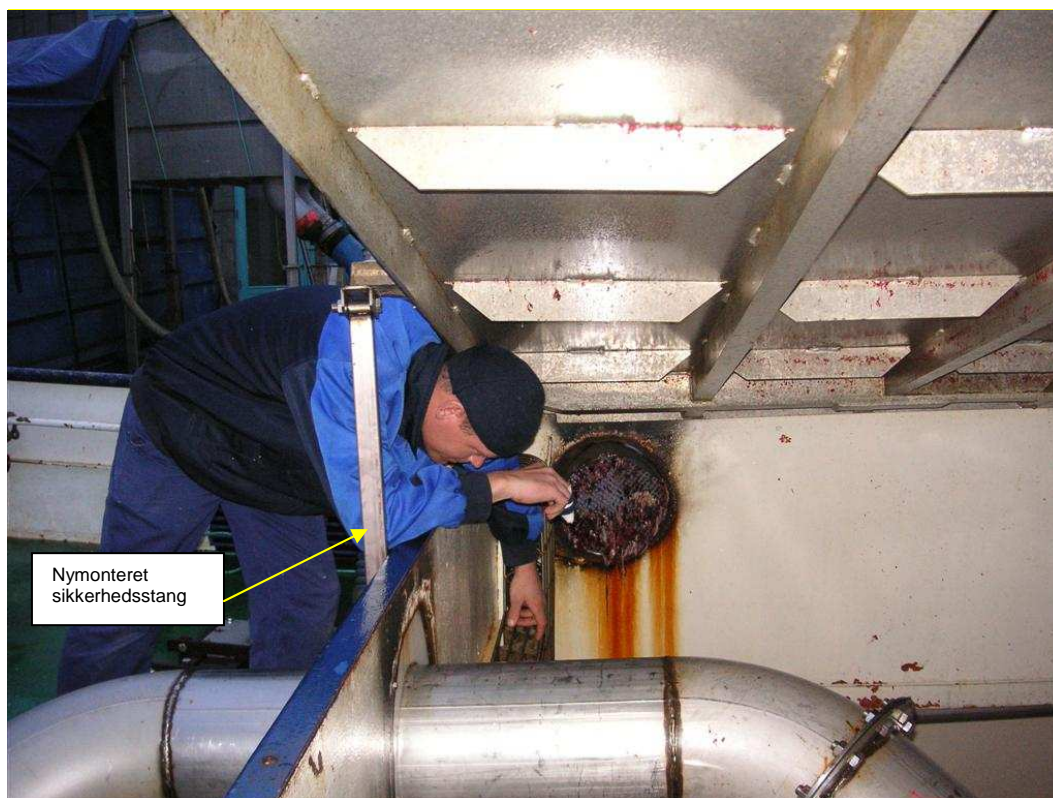
Kollegaen var imidlertid ikke gået i land. Han forsøgte med armen at skubbe to fisk ned fra en rist lige inden for lugekarmens agterste side (se billede nedenunder). Han kunne dog ikke umiddelbart nå begge fisk og stak derfor hovedet ind under det delvist åbentstående lugedæksel for bedre at kunne nå den sidste fisk (omtrent som vist på billedet nedenfor). I det samme begyndte lugen at lukke, hvorved han mærkede, at hovedet kom i klemme, og han skreg op. Besætningsmedlemmet ved betjeningshåndtaget hørte skriget, og rent reflektorisk skubbede han håndtaget den modsat vej og standsede dermed lukningen.

Nymonteret  
sikkerhedsstang

Figurant viser den omtrentlige situation

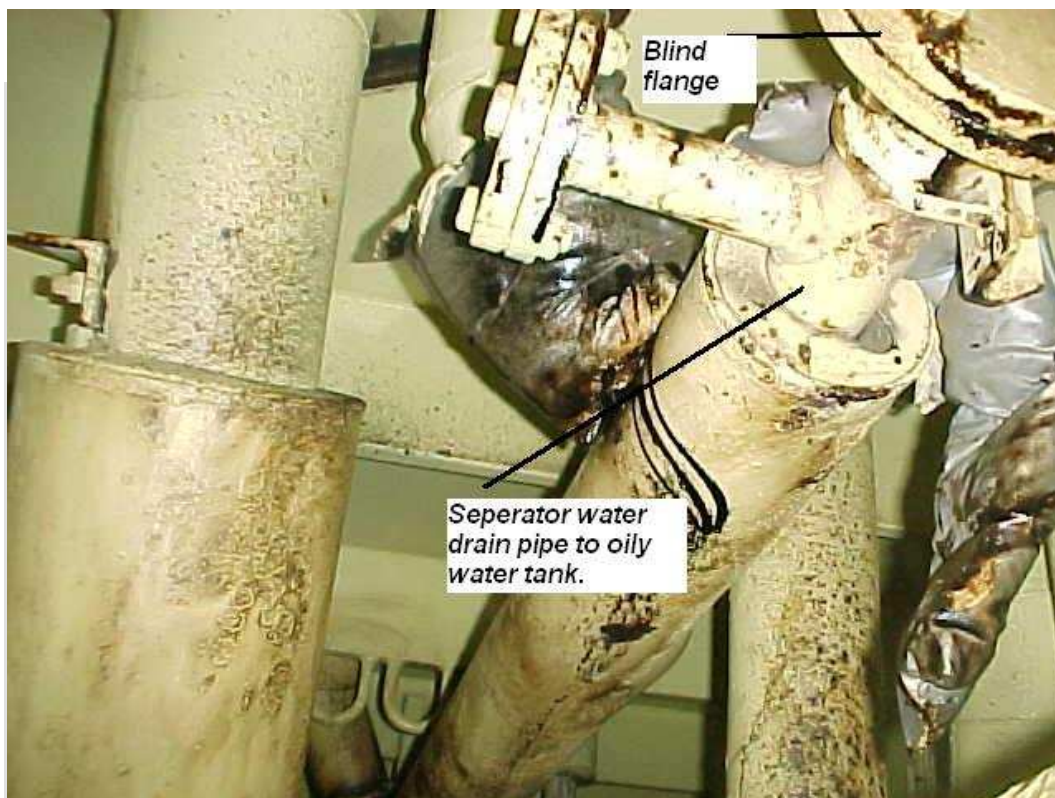
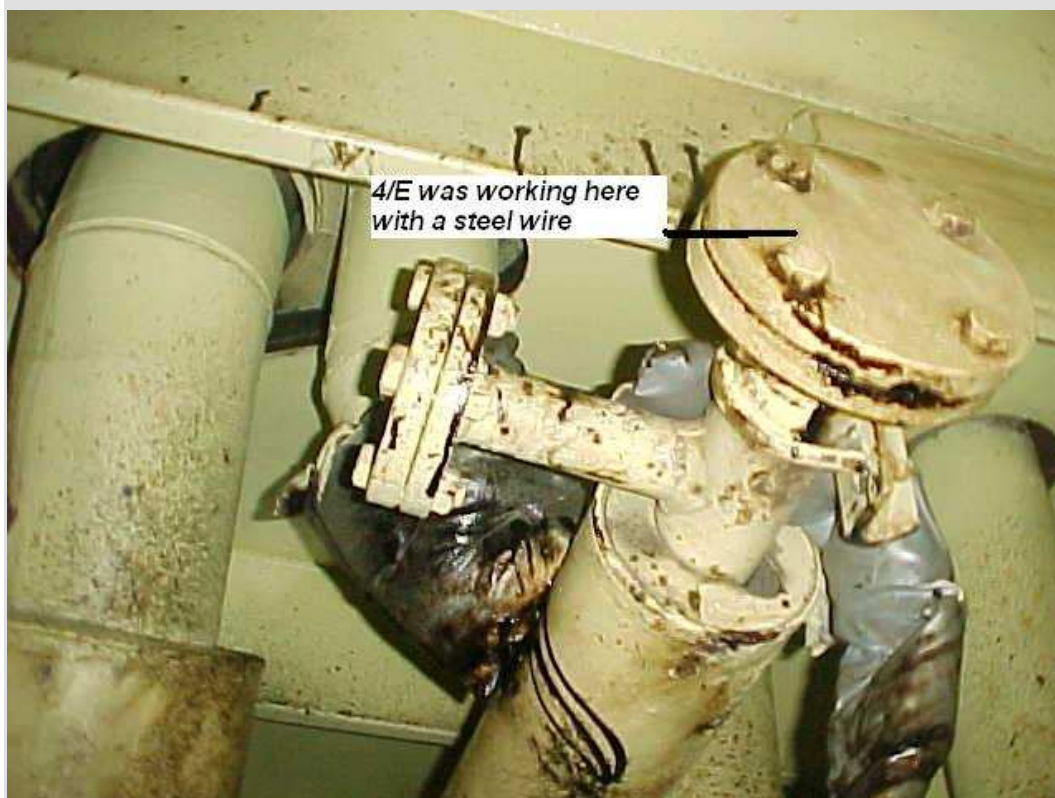
Photo: chief engineer, m/v SORØ MÆRSK

First, he dismantled the draining cap from separator and saw the pipe was clogged inside. He poured some diesel oil into the drain, trying to dissolve the sludge but nothing happened. After that, he tried to poke a wire rope into the pipe, but likewise with no effect.

He tracked the drain pipe and found a visiting flange (blind flange) right under the ceiling in the generator room situated under the fuel oil separator room.

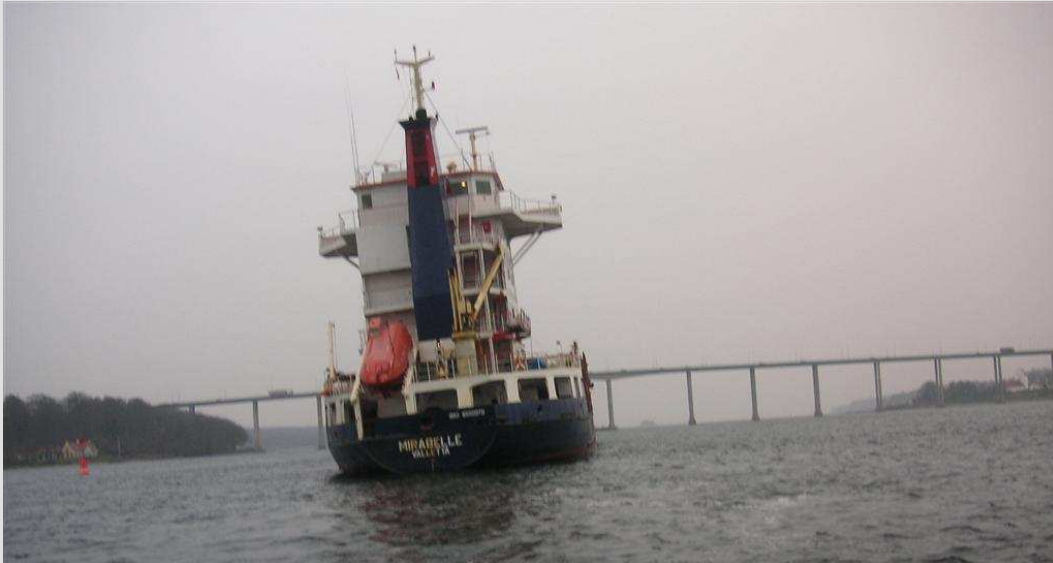
Fig. 1. MIRABELLE on ground. Photo by the Investigation Division

During high water and change of current the vessel re-floated on 18 December at 0225 and returned to Svendborg. There was found no damage to the vessel.

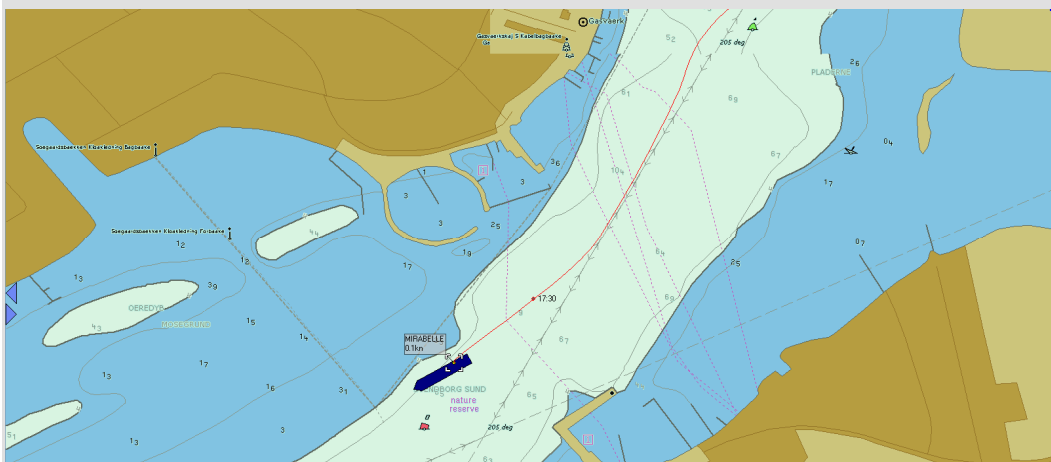
Immediately after MIRABELLE grounded approx. 30m north of the red buoy.

Fig. 2. Extract of AIS plot from the Danish Maritime Safety Administration

The fact that the master was alone on the bridge and should handle the manoeuvring, the navigation, the look-out and the handling of the search light is the main cause of the grounding. He did not notice the starboard turn, before it was too late to avoid the grounding.

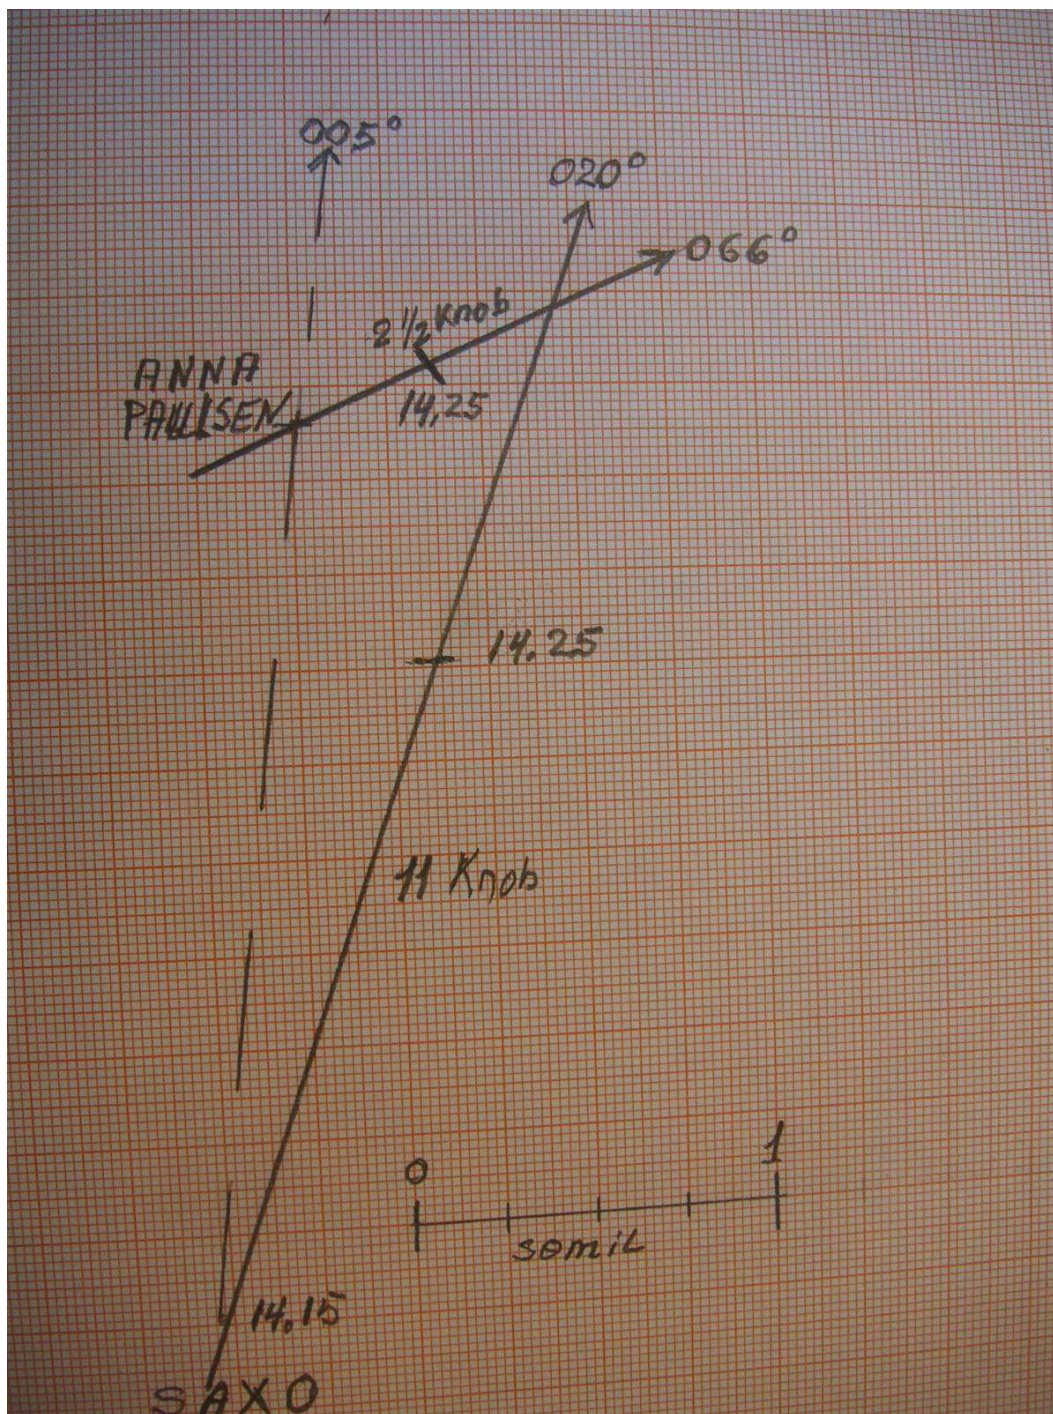
Figur 1. Skitse tegnet af Opklaringsenheden

SAXO's pejling til ANNA PAULSEN var ca. 15° om bagbord, det vil sige retvisende ca. 005°. ANNA PAULSEN sejlede på kurs 066°. SAXO var derfor indhentende skib i forhold til ANNA PAULSEN og havde som sådan vigepligt overfor ANNA PAULSEN i henhold til regel 13 i de internationale søvejsregler.

SAXO overholdt ikke sin vigepligt i henhold til regel 13.

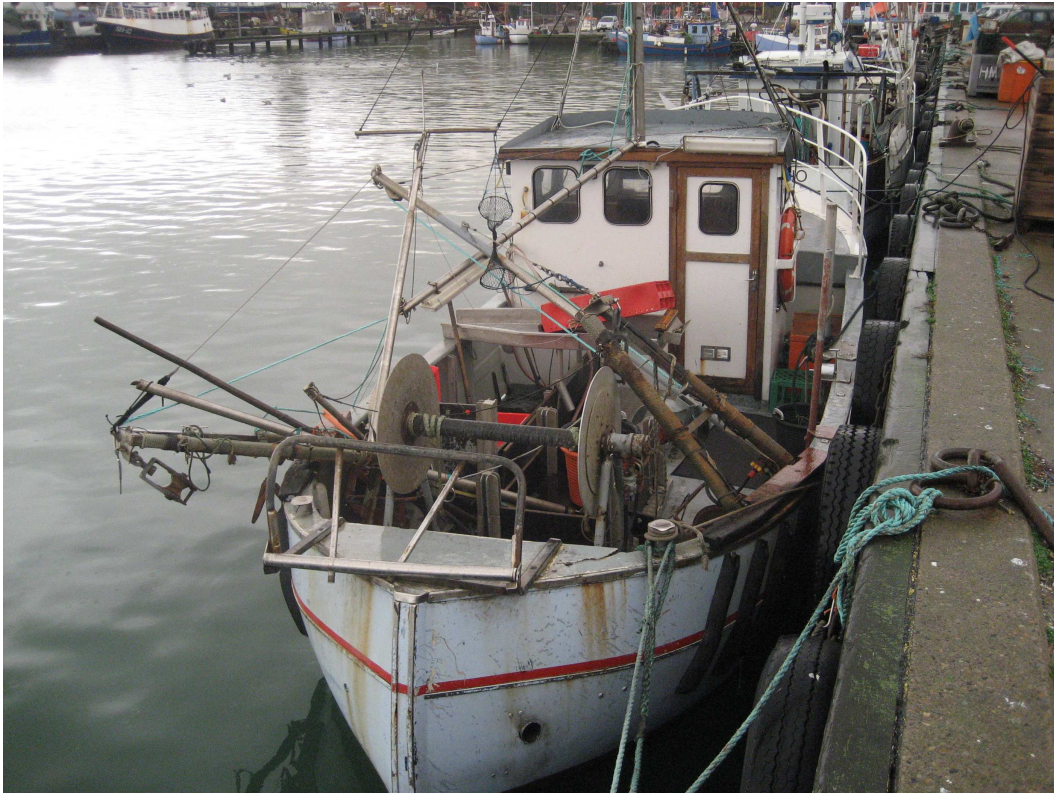
Kl. 14.25, hvor ANNA PAULSEN slæbte på kurs 066°, blev fiskeskibet pludselig slynget rundt i styrehuset, og lidt efter klappede ANNA PAULSEN mod styrbord side af SAXO. Samtidig knækkede trawlwiren, og ANNA PAULSEN kom fri af SAXO. Ved sammenstødet knækkede daviderne, mesanmasten og trawlstativet, og der skete skader på skroget agter.

Figur 2. ANNA PAULSEN efter kollisionen. Foto taget af Skibsforsikringen i Frederikshavn.

Ovenstående billede viser, at ANNA PAULSEN førte fiskesignal for trawlfiskeri i mesanmasten.

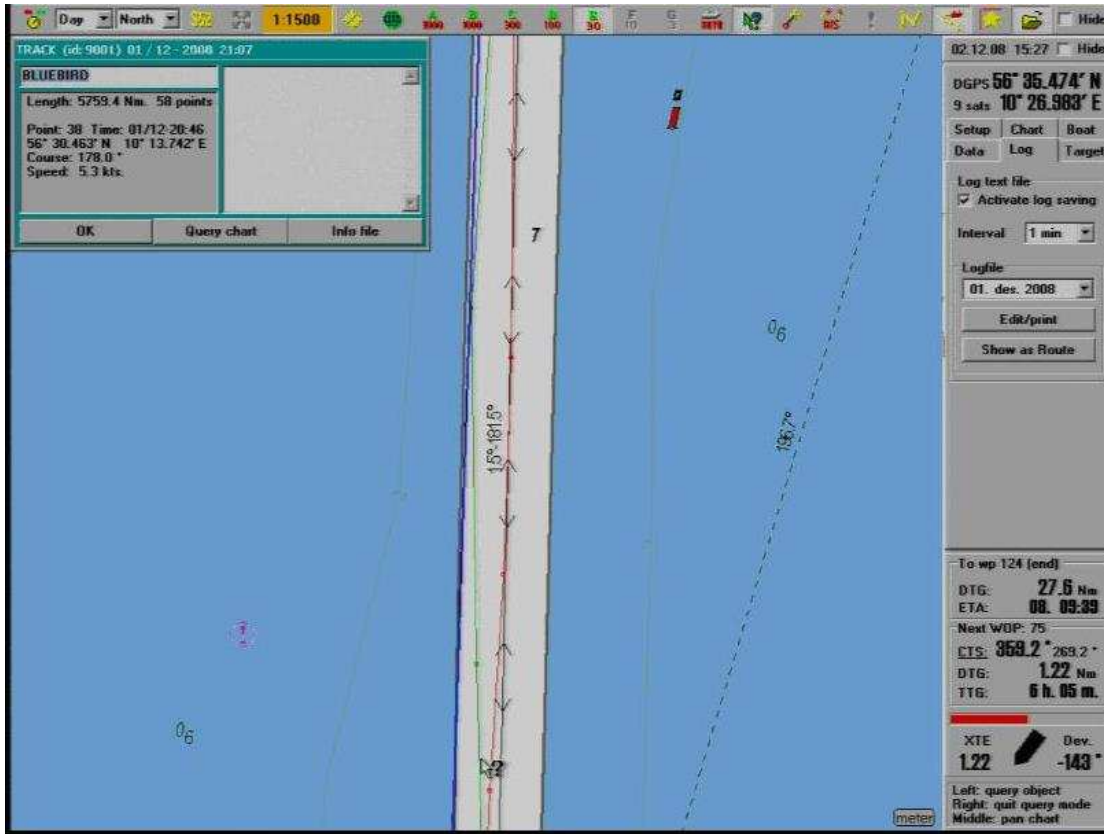
Fig. 2. – BLUE BIRD on the western edge of the dredged channel.

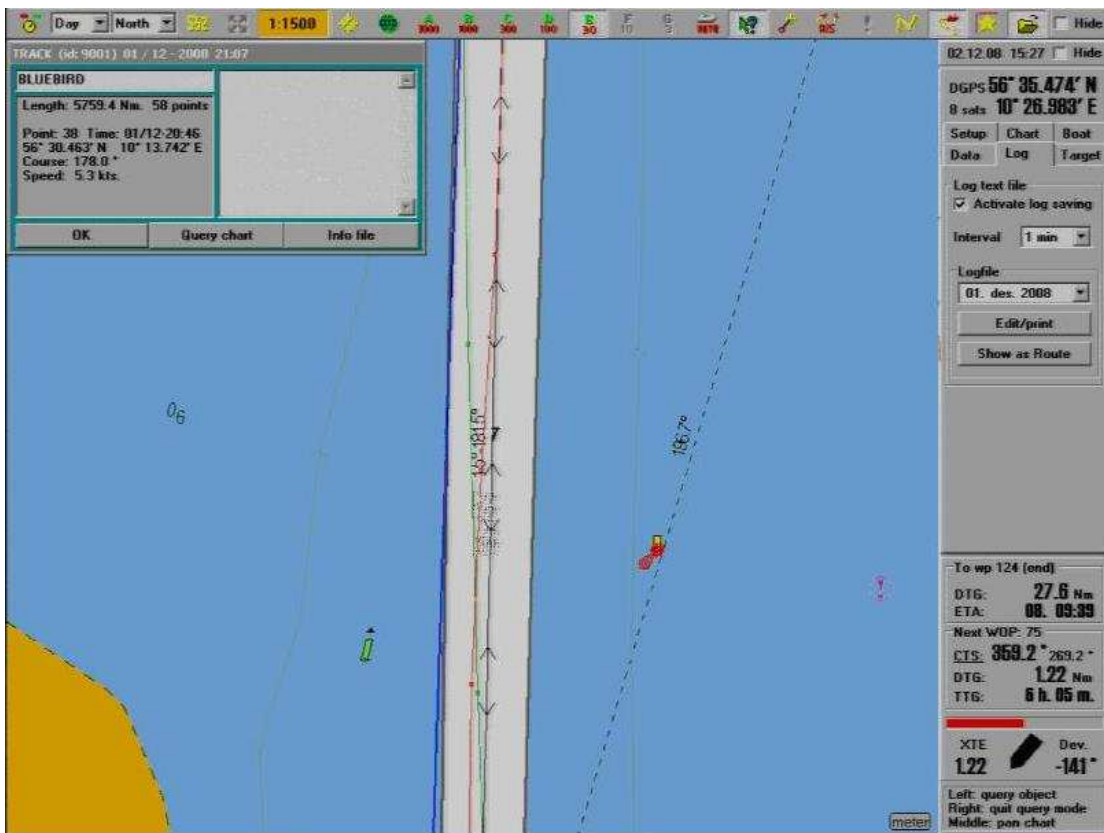
Fig. 3 – BLUE BIRD moving from the western edge towards the middle of the channel.

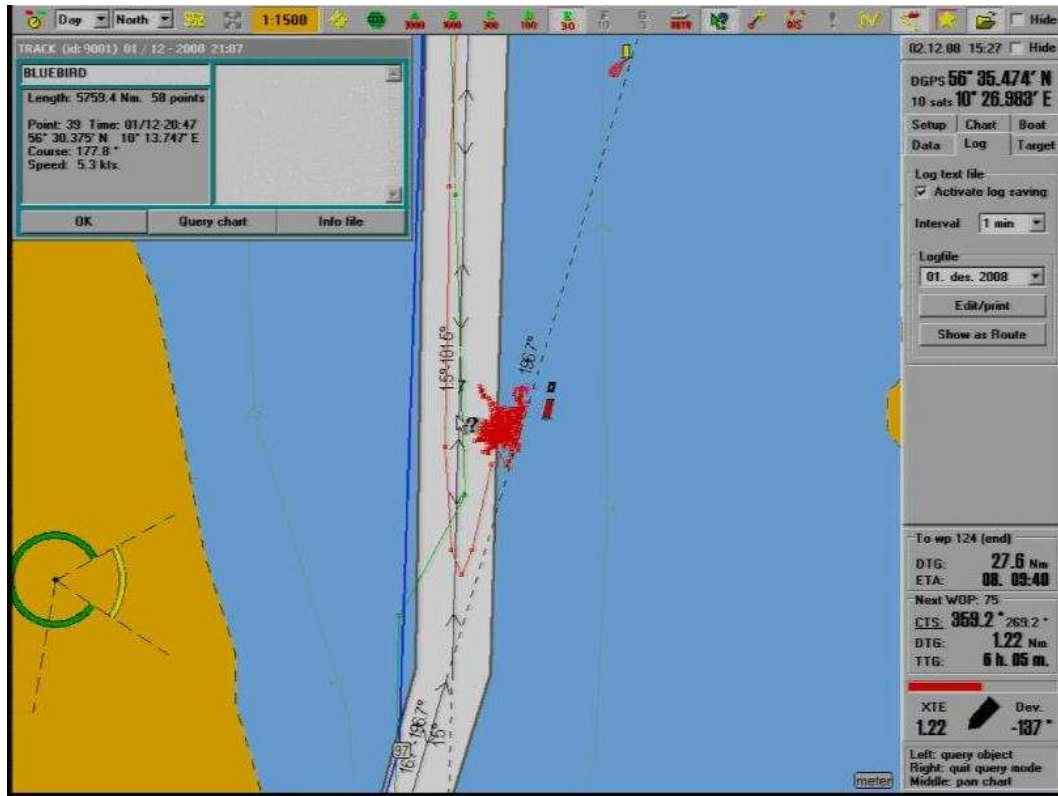
Fig. 4. – BLUE BIRD track continuing movement towards the middle. At the time of the collision, BLUE BIRD AIS-antenna seen on the eastern side of the channel.

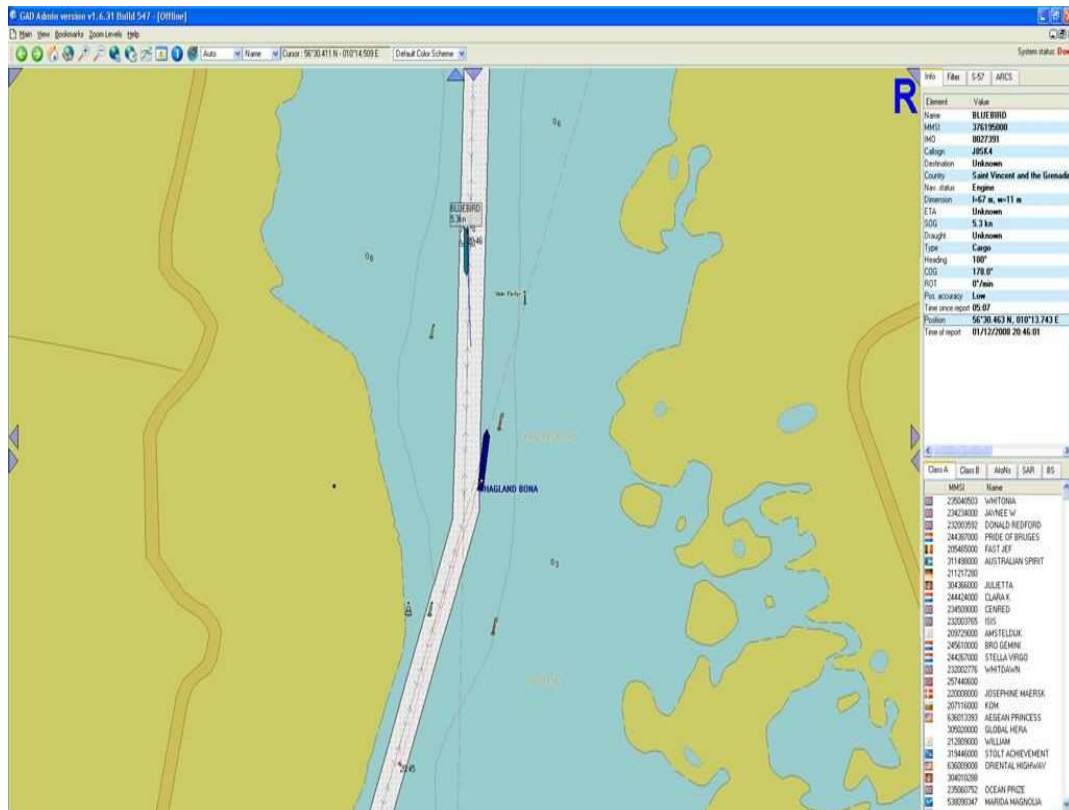
Fig. 4 – AIS-plot showing the HAGLAND BONA track prior to the collision.

AIS-data from the Danish Maritime Safety Administration (see fig.4) shows the HAGLAND BONA AIS-track in the eastern part of the channel immediately prior to and the grounded position following the collision. The shown position of BLUE BIRD in this plot is not updated, as the BLUE BIRD position in the Danish Maritime Safety Administration system was not updated since 2046. The actual time on the screen-dump on Fig.4 is 20:51:06. The BLUE BIRD position shown on this plot is 05 minutes and 07 seconds old.

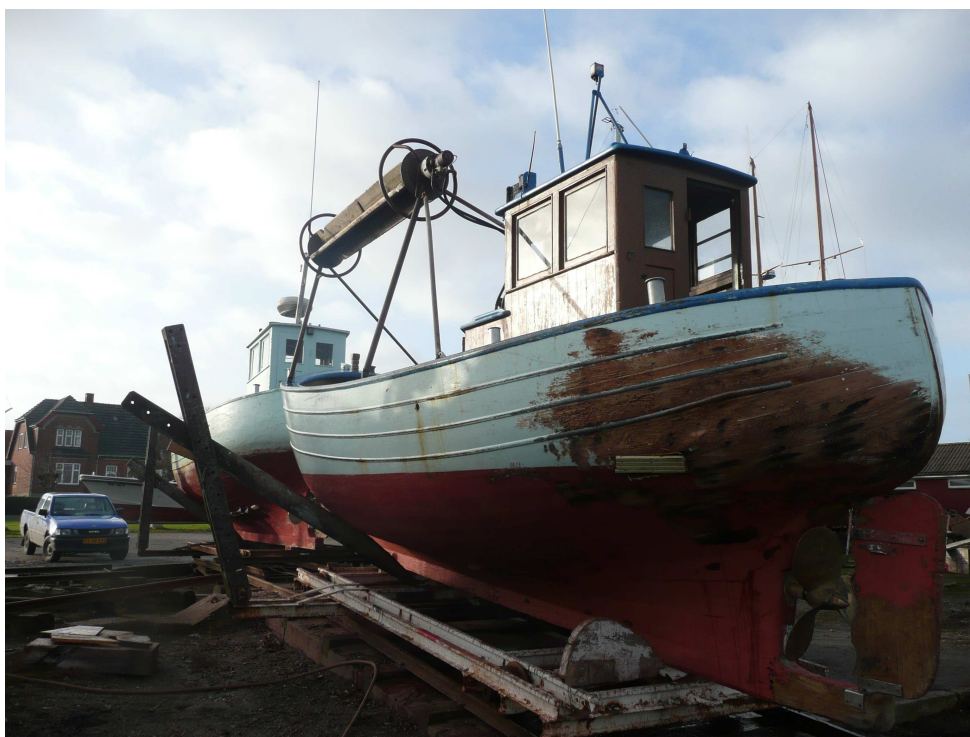
*FRANKVICKI på bedding i Stubbekøbing efter forliset. Foto: Opklaringsenheden*

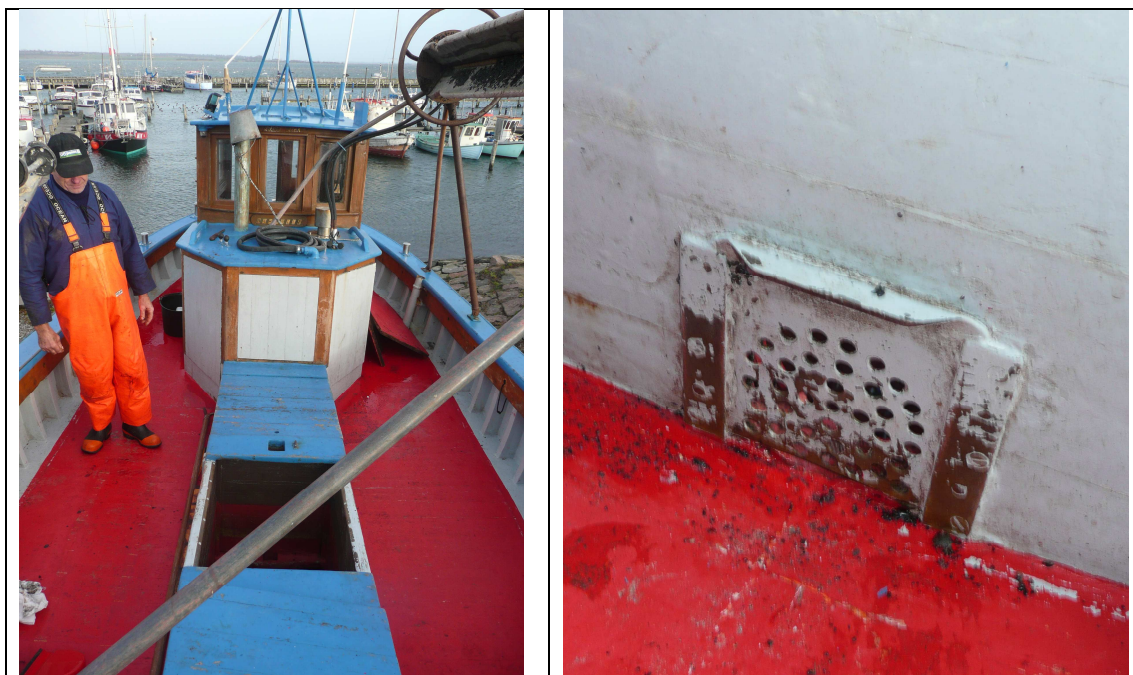
FRANKVICKI's dæk og dam

Lænsfrist til dam

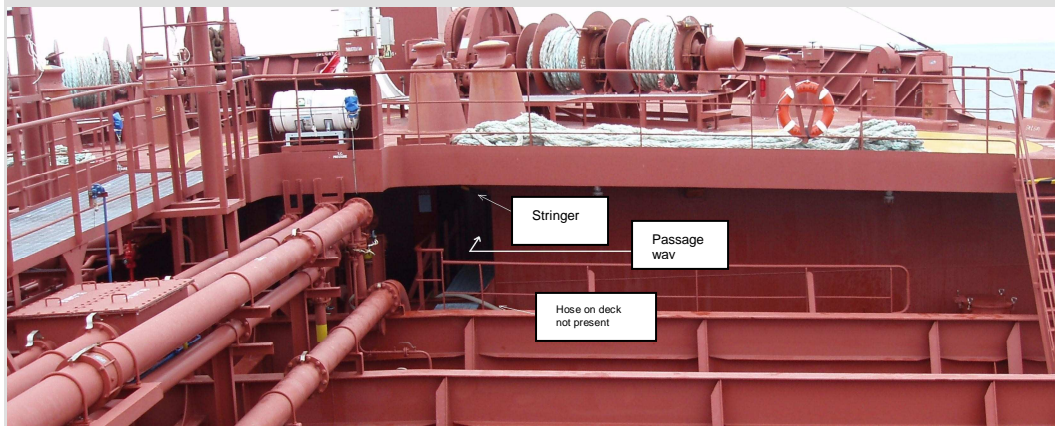
view to the forecastle and the place of the accident

On his way to the paint shop, when passing on a catwalk on the starboard entry below the forecastle, he hit his head against a stringer, and due to the heavy impact he was knocked out and fell down unconscious. He was not wearing a protective helmet.

- to emphasize to all seafarers employed by the company the importance of wearing a protective helmet as stated in the company's own instructions and
- to implement considered/planned alterations of the railing arrangement at the catwalk to ensure the safe passage beneath the stringer on this ship and on sister ships as well.

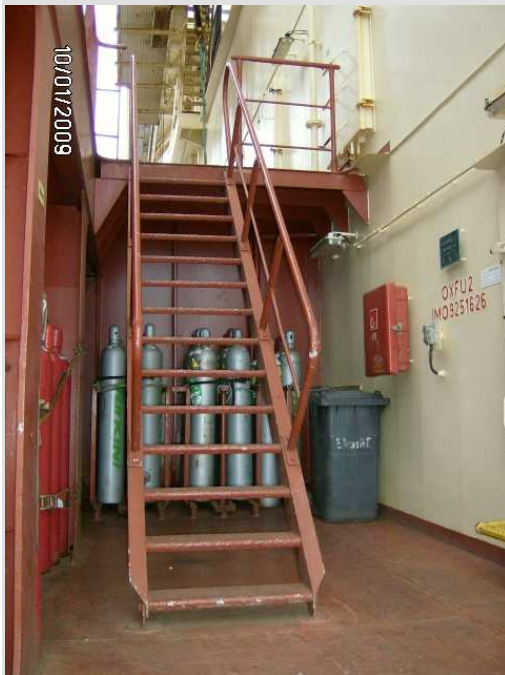
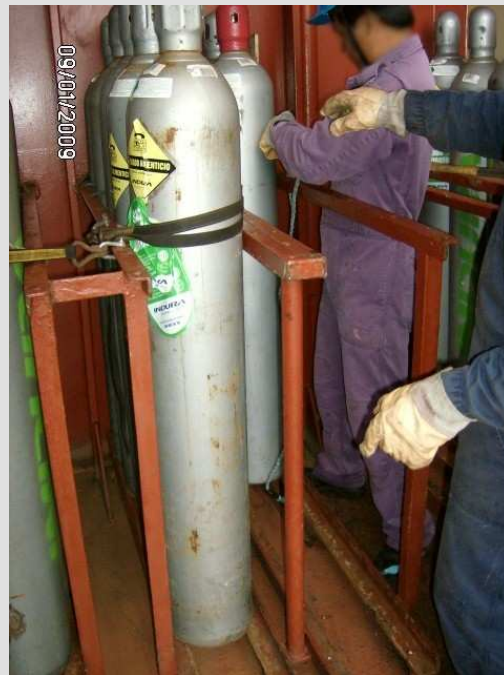
The cylinders' placement on the main deck aft of the accommodation

35 cylinders are placed in transverse racks on the main deck aft of the accommodation on the starboard side as shown on the picture. The rest of the cylinders are to be stowed directly on deck and lashed to the coaming of the aftermost hold.

The Investigation Division recommends the shipping company to investigate how to handle and store large amounts of CO<sub>2</sub> and oxygen cylinders in a more safe and easy way.

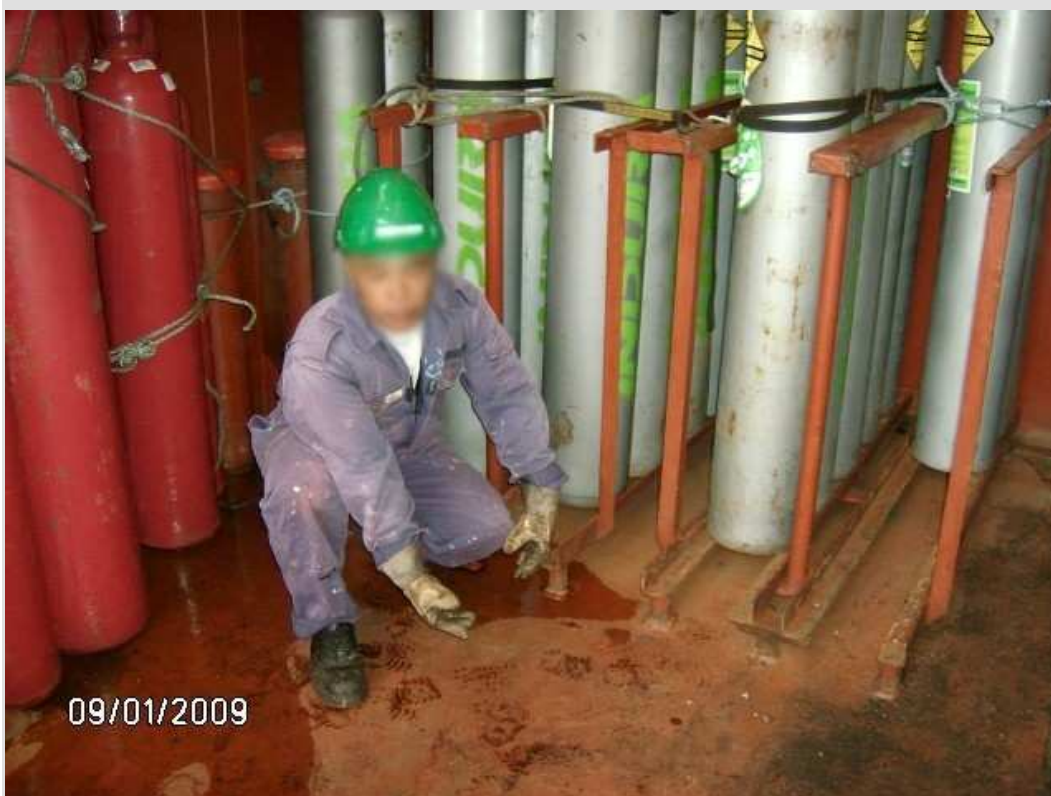
A crew member in the same position as in the situation of the accident

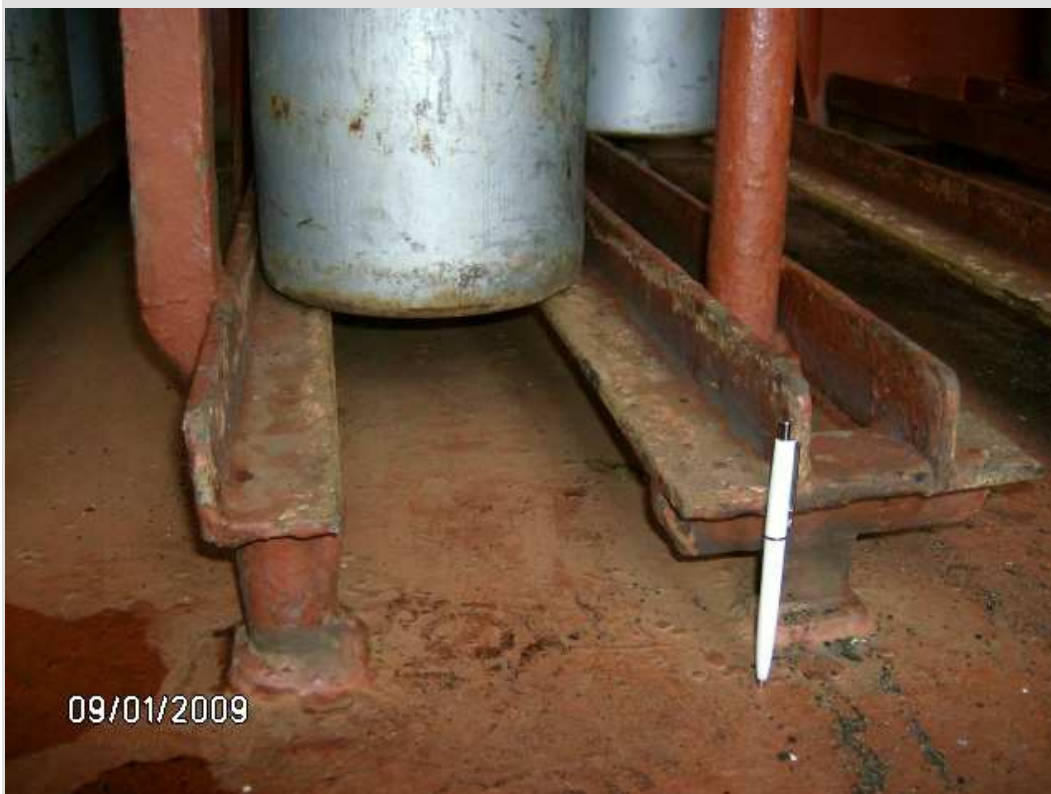
The bottom of CO<sub>2</sub> cylinders, not firmly standing in the racks

The work was not planned and organised to ensure safe working conditions.

The investigation Division recommends the shipping company to make the Safe Job Analysis that has been worked out for this ship after the accident valid for other ships handling gas cylinders in a similar way.
